**Flood Control Project Maintenance
Levee Inspections**
LMA District Cover Sheet
Spring 2018 Levee Inspection Results

Sutter Maintenance Yard Maintenance Area 0001

Spring 2018 Levee Inspection Results

Waterway			Bank	Unit Miles
Unit No. 01 Sacramento River			Right	16.76
	Spring (March - May)	Summer (June - August)	(September - November) Fall	Winter (December - February)
Unit Maintenance Rating (Fall Only)				
Date of Inspection	3/6/2018 - 3/6/2018			
DWR Inspector	Bob Duffey			
Accompanied By	Bryan Reniff Sutter Maintenance Yard

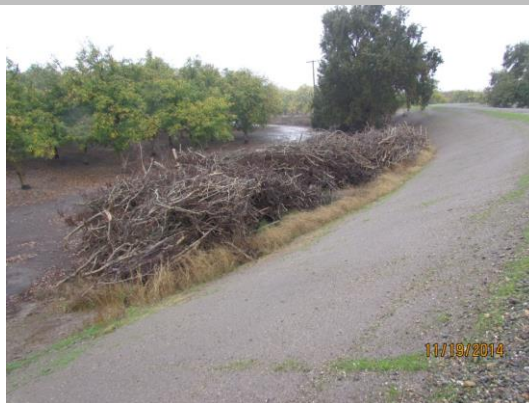
Photo 1 of 1 : SP_2018_MA0001_297_638_20180305_00044.jpg

LM Start	10.96	Rating **	M	Issue No.	638
LM End	10.96	Issue Type +	En	Location *	LS
Category	Earthen Levee			GPS Latitude/Longitude	
				Start	End
Item	Encroachments			39.340217 °	39.340217 °
				-122.032605 °	-122.032605 °
DWR ID	DWR_MA0001_01_f_2014_638				
Comment Code					
PR : Prunings					
Inspector Comment					
Remove prunings from the landside toe.

View of the pruning along the landside toe.

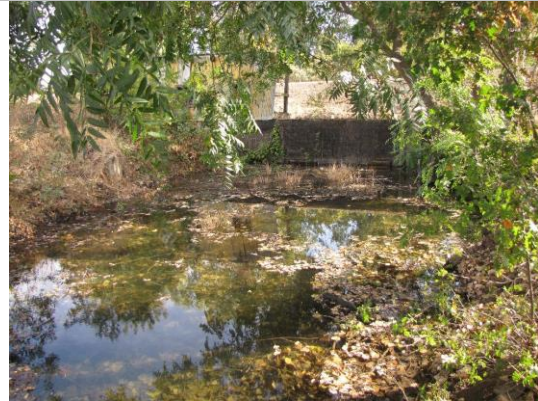
Photo 3 of 3 : UCIP_SP_2018_51889_70260.jpg

FS_ID:51889
DS_ID:16449
EP_NO: 187
Repair Type: Non-Urgent
Crossing Status: Found
UCIP Comments: 5/3/2017 No changes have been made to this crossing since the NOV was sent out in January 2017. (DWR Sutter Yard- A Freitag)01/31/2017 Informal Notice of Violation (NOV) was sent out January 31, 2017 by DWR Flood Maintenance Office--owner will need to coordinate with CVFPB to remove, replace, or abandon pipe in-place. Owner has until Monday February 27th, 2017 to respond to DWR contact: Bryan Reniff. (refer to Official Notice for details). (DWR UCIP - O. Magana)10/24/2016 Appears abandoned. Slide gate needs to be dug out and fully closed to prevent water flow during high water.(DWR Sutter Yard- A Freitag)4/25/2016 Crossing appears to be abandoned.4/21/2015 Same as last inspection.6/23/2014 Same as last inspection.12/17/2013 Same as last inspection.7/18/2013 Same as last inspection.10/30/2012 Need to determine if structure is still in use--contact owner. If abandoned structure--structure needs to be properly abandoned. This crossing was listed in the USACE Periodic Inspections as ID# USACE_CESPK_MA1C_2010_p_0393 missing gate. FIELD_STRUCT_DESC: 1 of 2: 52-inch corrugated metal irrigation pipe, 48-inch measured, through the levee, approximately 15 feet below the crown. Slide gate on the waterside (WS) and flap gate on the landside (LS). Concrete headwalls at both WS and LS. This structure is associated with another abandoned structure located on the WS. Abandoned structure includes pump house, multiple concrete walls, and 3 additional crossings (two 30-inch pipes and one 48-inch pipe). (Original structure installed under Permit No. 187, 1921 - Compton-Delevan Irrigation District-Maxwell I.D., new pump and platform installed and old pump house removed under Permit No. 9183-1973, Maxwell Irrigation District) [Additional Reference(s): DWR Levee Log, 1992]. FS Date: 5/23/2017 10:44:24 AM

Drain channel inside ring levee.

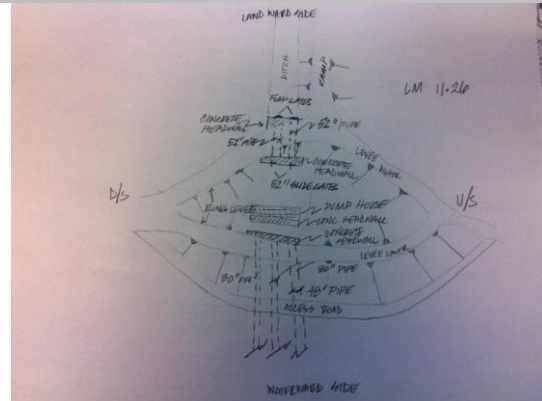
Photo 1 of 3 : UCIP_SP_2018_51891_70272.jpg

FS_ID:51891
DS_ID:17572
EP_NO: 187
Repair Type: Urgent
Crossing Status: Found
UCIP Comments: 5/3/2017 No changes have been made at this crossing since the NOV was sent out in January 2017. (DWR Sutter Yard- A Freitag)01/31/2017 Informal Notice of Violation (NOV) was sent out January 31, 2017 by DWR Flood Maintenance Office--owner will need to coordinate with CVFPB to remove, replace, or abandon pipe in-place. Owner has until Monday February 27th, 2017 to respond to DWR contact: Bryan Reniff. (refer to Official Notice for details). (DWR UCIP - O. Magana)10/24/2016 Appears abandoned. Slide gate needs to be replaced or pipe end capped to prevent water flow during high water. (DWR Sutter Yard- A Freitag)4/25/2016 Crossing appears to be abandoned. Slide gate needs to be replaced or pipe needs to be plugged to prevent water flow during high water season. (DWR Sutter Yard - a Freitag)4/21/2015 Same as last inspection. (DWR Sutter Yard - a Freitag)6/23/2014 Same as last inspection. (DWR Sutter Yard - a Freitag)12/17/2013 Same as last inspection. (DWR Sutter Yard - a Freitag)7/18/2013 Same as last inspection. (DWR Sutter Yard - a Freitag)10/30/2012 Missing positive closure device. Need to determine if structure is still in use--contact owner. If abandoned structure--structure needs to be abandoned properly. This crossing was listed in the USACE Periodic Inspections as ID# USACE_CESPK_MA1C_2010_p_0393 missing gate. (DWR UCIP - omagana)

FIELD_STRUCT_DESC: 2 of 2: 52-inch corrugated metal irrigation pipe, 48-inch measured (2012), through the levee, approximately 15 feet below the crown. Slide gate on the waterside (WS) and flap gate on the landside (LS). Concrete headwalls at both ends. This structure is associated with another abandoned structure located on the WS. Abandoned structure includes pump house, multiple concrete walls, and 3 additional crossings (two 30-inch pipes and one 48-inch pipe). (Original structure installed under Permit No. 187, 1921 - Compton-Delevan Irrigation District-Maxwell I.D., new pump and platform installed and old pump house removed under Permit No. 9183-1973, Maxwell Irrigation District) [Additional Reference(s): DWR Levee Log, 1992].
FS Date: 5/23/2017 10:48:04 AM

Sketch of structure through levee ring located at levee mile 11.26.

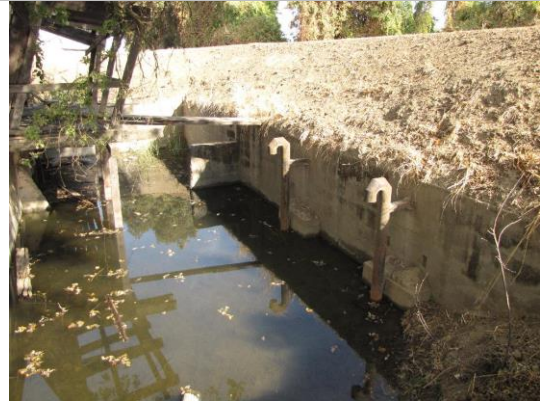
Photo 3 of 3 : UCIP_SP_2018_51891_70275.jpg

FS_ID:51891
DS_ID:17572
EP_NO: 187
Repair Type: Urgent
Crossing Status: Found
UCIP Comments: 5/3/2017 No changes have been made at this crossing since the NOV was sent out in January 2017. (DWR Sutter Yard- A Freitag)01/31/2017 Informal Notice of Violation (NOV) was sent out January 31, 2017 by DWR Flood Maintenance Office--owner will need to coordinate with CVFPB to remove, replace, or abandon pipe in-place. Owner has until Monday February 27th, 2017 to respond to DWR contact: Bryan Reniff. (refer to Official Notice for details). (DWR UCIP - O. Magana)10/24/2016 Appears abandoned. Slide gate needs to be replaced or pipe end capped to prevent water flow during high water. (DWR Sutter Yard- A Freitag)4/25/2016 Crossing appears to be abandoned. Slide gate needs to be replaced or pipe needs to be plugged to prevent water flow during high water season. (DWR Sutter Yard - A Freitag)4/21/2015 Same as last inspection. (DWR Sutter Yard - A Freitag)6/23/2014 Same as last inspection. (DWR Sutter Yard - A Freitag)12/17/2013 Same as last inspection. (DWR Sutter Yard - A Freitag)7/18/2013 Same as last inspection. (DWR Sutter Yard - A Freitag)10/30/2012 Missing positive closure device. Need to determine if structure is still in use--contact owner. If abandoned structure--structure needs to be abandoned properly. This crossing was listed in the USACE Periodic Inspections as ID# USACE_CESPK_MA1C_2010_p_0393 missing gate. (DWR UCIP - O Magana)

FIELD_STRUCT_DESC: 2 of 2: 52-inch corrugated metal irrigation pipe, 48-inch measured (2012), through the levee, approximately 15 feet below the crown. Slide gate on the waterside (WS) and flap gate on the landside (LS). Concrete headwalls at both ends. This structure is associated with another abandoned structure located on the WS. Abandoned structure includes pump house, multiple concrete walls, and 3 additional crossings (two 30-inch pipes and one 48-inch pipe). (Original structure installed under Permit No. 187, 1921 - Compton-Delevan Irrigation District-Maxwell I.D., new pump and platform installed and old pump house removed under Permit No. 9183-1973, Maxwell Irrigation District) [Additional Reference(s): DWR Levee Log, 1992].
FS Date: 5/23/2017 10:48:04 AM

WS-Concrete headwall with multiple crossings (2-30 inch pipes and 1-48 inch pipe).

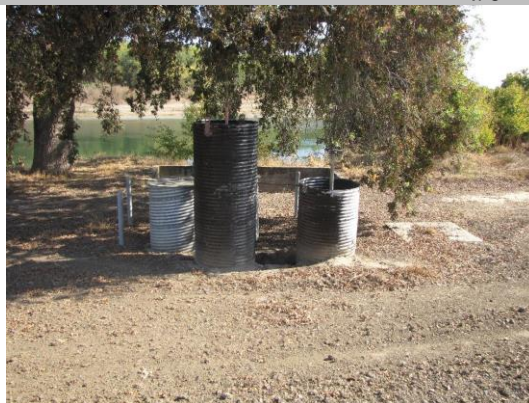
Photo 3 of 3 : UCIP_SP_2018_51893_70330.jpg

Item	DWR UCIP Field Study			39.343263 °	39.343263 °	
				-122.032152 °	-122.032152 °	
DWR ID						
Comment Code						
Inspector Comment						
FS_ID:51893 DS_ID:17691 EP_NO: 17471 Repair Type: Urgent Crossing Status: Found UCIP Comments: 5/3/2017 Sink hole still present between the WS risers. It does not appears to be getting worse. Pumps were running during site visit but the sink hole was dry this time. (DWR Sutter Yard-AFreitag)10/24/2016 Sinkhole still present.(DWR Sutter Yard-AFreitag)4/25/2016 Sink hole between the standpipes seems to be getting worse. Measurements of the hole are 3' wide x 3' long x 3' deep. The pipe was flowing water and there was water present in the bottom of the sink hole. (DWR Sutter Yard - afreitag)4/21/2015 Sink hole still present between risers. (DWR Sutter Yard - afreitag)6/23/2014 Standing water was present in the bottom of the sinkhole. (DWR Sutter Yard - afreitag)12/17/2013 Same as last inspection. (DWR Sutter Yard - afreitag)7/18/2013 Same as last inspection. (DWR Sutter Yard - afreitag)10/30/2012 Erosion between risers with slide gates located on waterward side; This crossing was listed in the USACE Periodic Inspections as ID# USACE_CESPK_MA1C_2010_p_0398 for possible sinkhole between access gate structures. (DWR UCIP - omagana) FIELD_STRUCT_DESC: 1 of 2: 24-inch high-density polyethylene (HDPE) irrigation pipe to be connected to the existing corrugated metal pipe (CMP) riser within the waterside (WS) and parallel to the right (west) bank levee of the Sacramento River. (Permit 17471, 2002 - Maxwell Irrigation District). FS Date: 5/23/2017 10:52:09 AM

CMP risers located on WS berm. 18-inch pipe corresponds to downstream riser with slide gate. 24-inch pipe corresponds to upstream riser with slide gate.

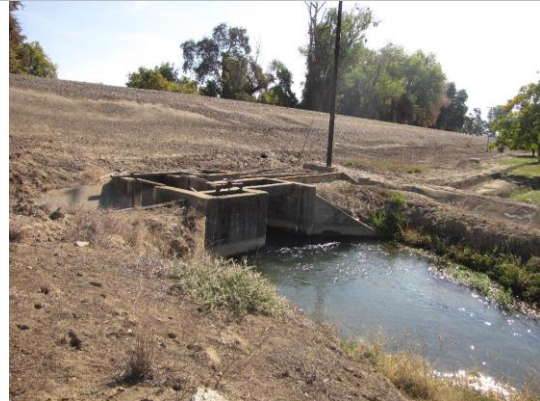
Photo 2 of 3 : UCIP_SP_2018_51894_70324.jpg

FS_ID:51894
DS_ID:17624
EP_NO: 17471
Repair Type: Urgent
Crossing Status: Found
UCIP Comments: 5/3/2017 Sink hole still present between the WS risers. It does not appears to be getting worse. Pumps were running during site visit but the sink hole was dry this time. (DWR Sutter Yard-AFreitag)10/24/2016 Sinkhole still present.(DWR Sutter Yard-AFreitag)4/25/2016 Sink hole between risers was getting worse (3' wide x 3' long x 3' deep). New smaller sink hole is appearing on the upstream side of this stand pipe (4.5" wide x 20" deep). (DWR Sutter Yard - afreitag)4/21/2015 Sink hole still present between risers. (DWR Sutter Yard - afreitag)6/23/2014 Standing water was present in the bottom of the sinkhole. (DWR Sutter Yard - afreitag)12/17/2013 Same as last inspection. (DWR Sutter Yard - afreitag)7/18/2013 Same as last inspection. (DWR Sutter Yard - afreitag)10/30/2012 Erosion between risers with slide gates located on waterward side; This crossing was listed in the USACE Periodic Inspections as ID# USACE_CESPK_MA1C_2010_p_0398 for possible sinkhole between access gate structures. (DWR UCIP - omagana)

View of concrete distribution box located on LS toe.

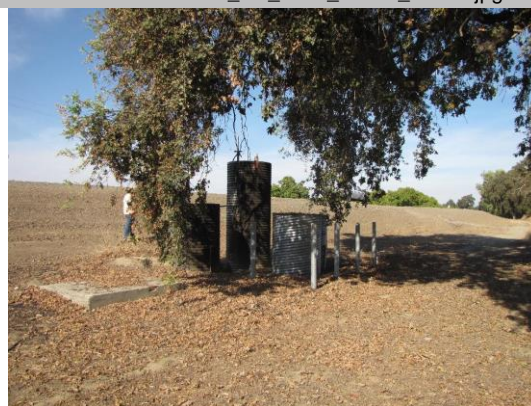
Photo 3 of 3 : UCIP_SP_2018_51894_70323.jpg

Item	DWR UCIP Field Study			39.343283 °	39.343283 °	
				-122.032145 °	-122.032145 °	
DWR ID						
Comment Code						
Inspector Comment						
FS_ID:51894 DS_ID:17624 EP_NO: 17471 Repair Type: Urgent Crossing Status: Found UCIP Comments: 5/3/2017 Sink hole still present between the WS risers. It does not appears to be getting worse. Pumps were running during site visit but the sink hole was dry this time. (DWR Sutter Yard-AFreitag)10/24/2016 Sinkhole still present.(DWR Sutter Yard-AFreitag)4/25/2016 Sink hole between risers was getting worse (3' wide x 3' long x 3' deep). New smaller sink hole is appearing on the upstream side of this stand pipe (4.5" wide x 20" deep). (DWR Sutter Yard - afreitag)4/21/2015 Sink hole still present between risers. (DWR Sutter Yard - afreitag)6/23/2014 Standing water was present in the bottom of the sinkhole. (DWR Sutter Yard - afreitag)12/17/2013 Same as last inspection. (DWR Sutter Yard - afreitag)7/18/2013 Same as last inspection. (DWR Sutter Yard - afreitag)10/30/2012 Erosion between risers with slide gates located on waterward side; This crossing was listed in the USACE Periodic Inspections as ID# USACE_CESPK_MA1C_2010_p_0398 for possible sinkhole between access gate structures. (DWR UCIP - omagana) FIELD_STRUCT_DESC: 2 of 2: 18-inch high-density polyethylene (HDPE) irrigation pipe connected to the existing corrugated metal pipe (CMP) riser within the waterside (WS) and parallel to the right (west) bank levee of the Sacramento River. Pipe depth through the levee unknown. Pump station is located approximately 450 feet upstream of crossing. (Permit 17471, 2002 - Maxwell Irrigation District) FS Date: 5/23/2017 10:55:17 AM

View of CMP risers located on WS berm.

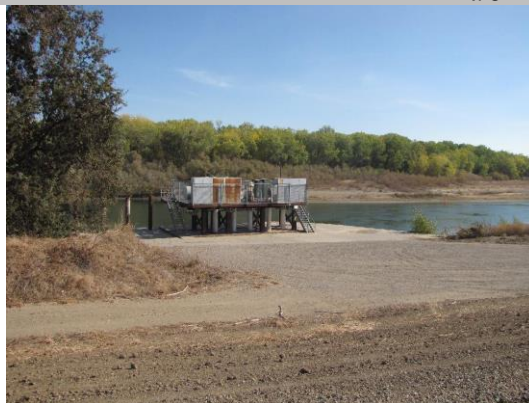
Photo 2 of 3 : UCIP_SP_2018_51900_70343.jpg

Maxwell Irrigation District Pump Station located on WS.

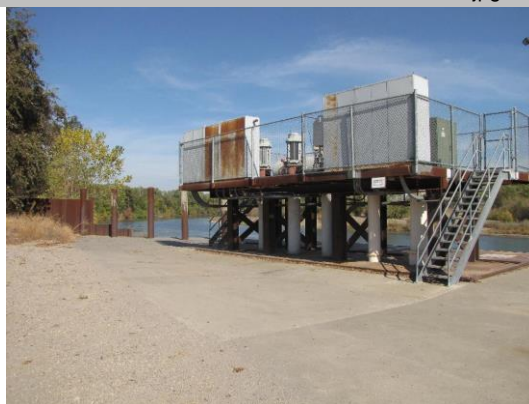
Photo 3 of 3 : UCIP_SP_2018_51900_70345.jpg

Maxwell Irrigation District Pump Station located on WS.

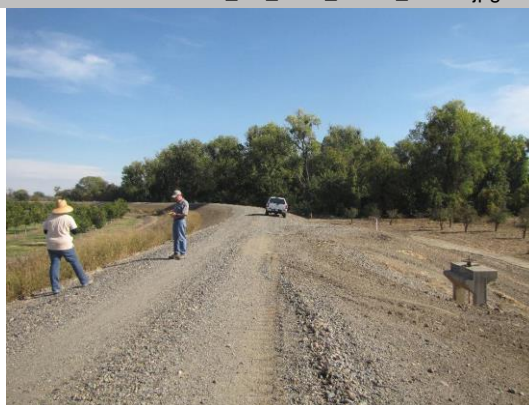
Photo 1 of 3 : UCIP_SP_2018_51903_70352.jpg

Comment Code					
Inspector Comment					
FS_ID:51903 DS_ID:16445 EP_NO: 9462 Repair Type: Non-Urgent Crossing Status: Found UCIP Comments: 5/3/2017 Appears abandoned- needs to be done properly.(DWR Sutter Yard- A Freitag)10/24/2016 Appears abandoned. LS concrete canal is filled by pipe DSID 16444.4/25/2016 Appears to be an abandoned crossing. WS slide gate still buried and inoperable.4/21/2015 Same as last inspection. 6/23/2014 Same as last inspection.12/17/2013 Same as last inspection.7/22/2013 Same as last inspection.10/30/2012 Slide gate unoperable-blocked by sediment. LS-flap gate missing. 5-inch pipe goes through 24-inch crossing--unable to determine is authorized. This crossing was listed in the USACE Periodic Inspections as ID# USACE_CESPK_MA1C_2010_p_0435 for smaller pipe running inside existing crossing. FIELD_STRUCT_DESC: *ABANDONED* 24-inch corrugated metal drainage pipe through the levee, approximately 10 feet below the crown. Slide gate on both waterside (WS) and landside (LS). Gate missing on the LS. (Automatic Board Order (ABO) issued as Permit No. 9462-1974, Thousand Acre Ranch) [Additional Reference(s): DWR Levee Log, 1992]. FS Date: 5/23/2017 11:50:30 AM

Overview of levee crown looking downstream at crossing.

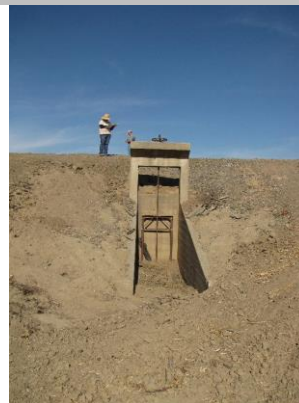
Photo 2 of 3 : UCIP_SP_2018_51903_70351.jpg

WS concrete structure with slide gate. Gate is blocked by sediment.

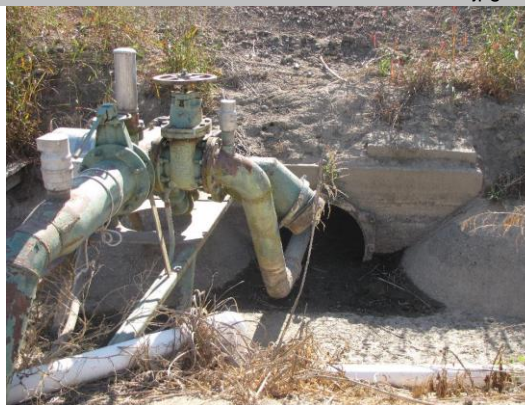
Photo 3 of 3 : UCIP_SP_2018_51903_70350.jpg

6-inch irrigation pipe through crossing at LS. Flap gate missing.

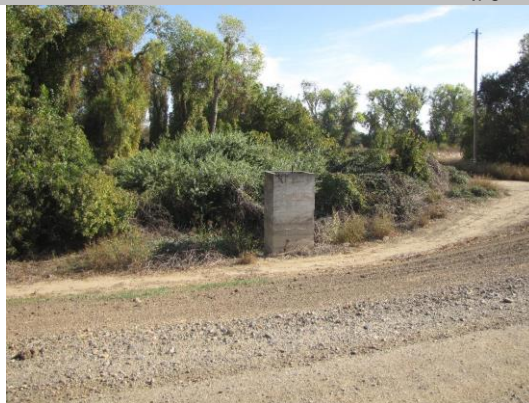
Photo 2 of 3 : UCIP_SP_2018_51908_70376.jpg

FS_ID:51908
DS_ID:16443
EP_NO: 9461
Repair Type: Urgent
Crossing Status: Found
UCIP Comments: 5/3/2017 Water was leaking from the LS distribution box during the Jan/Feb 2017 high water event. If this crossing is abandoned then it needs to be so properly. (DWR Sutter Yard- A Freitag) 11/01/2016 Erosion/cavity collapse visible on LS toe. Slide gate inside concrete riser located on the WS is in the open position. Need to contact owner to confirm status of crossing and to determine cause of erosion on LS (pipe or concrete box might be leaking). (O. Magana - DWR UCIP) 10/24/2016 Appears abandoned. (DWR Sutter Yard- A Freitag) 4/25/2016 Slide gate in WS box visually appears to be closed as its stem is all the way down. Still cannot look into box to confirm 100% though. (A. Freitag - DWR Sutter Yard) 4/21/2015 Same as last inspection. (A. Freitag - DWR Sutter Yard) 6/23/2014 Same as last inspection. (A. Freitag - DWR Sutter Yard) 12/17/2013 Same as last inspection. (A. Freitag - DWR Sutter Yard) 7/22/2013 Same as last inspection. (A. Freitag - DWR Sutter Yard) 10/30/2012 Unable to close positive closure device due to missing ladder-sluce gate inaccessible. Need to determine the condition of the gate. This crossing was listed in the USACE Periodic Inspections as ID# USACE_CESPK_MA1C_2010_p_0453 for an inaccessible gate box with its ladder broken on the waterward side. (O. Magana - DWR UCIP) FIELD_STRUCT_DESC: 36-inch corrugated metal irrigation pipe through the levee, 21.5 feet below the crown. Slide gate in concrete box on the waterside (WS) end. Pump on the bank. Tall concrete box located on the landside (LS). (Automatic Board Order (ABO) issued as Permit No. 9461, 1974 - Annie D. Propfe) [Additional Reference(s): DWR Levee Log, 1992. USACE Sacramento O&M Manual 137, August 1955, (Station 710+82)].

View of WS at crossing.

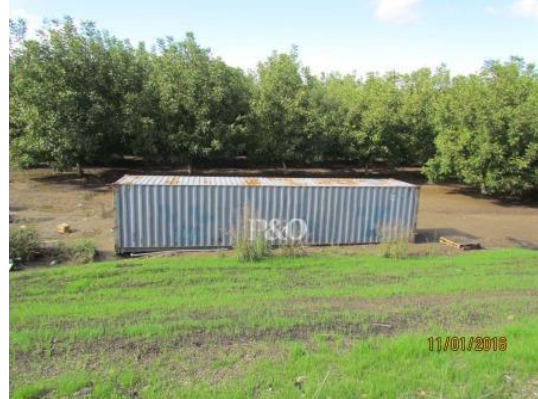
Photo 1 of 1 : SP_2018_MA0001_297_126_20180305_00036.jpg

LM Start	13.48	Rating **	M	Issue No.	126
LM End	13.48	Issue Type +	En	Location *	LS
Category	Earthen Levee			GPS Latitude/Longitude	
				Start	End
Item	Encroachments			39.367832 °	39.367832 °
				-122.015130 °	-122.015130 °
DWR ID	DWR_MA0001_01_f_2016_126				
Comment Code					
EQ : Equipment					
Inspector Comment					
Shipping container stored on landside toe.

View of a shipping container along the landside toe.

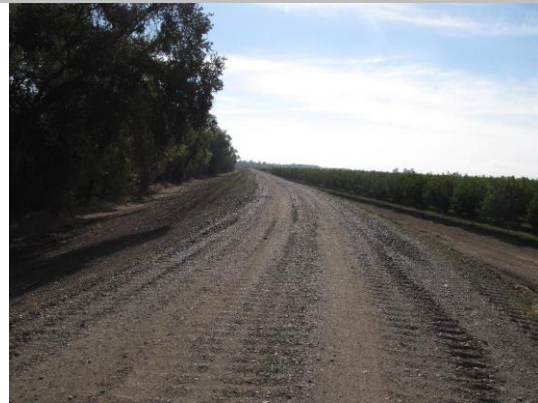
Photo 1 of 2 : UCIP_SP_2018_51910_70379.jpg

LM Start	13.79	Rating **	M	Issue No.	675	
LM End	13.79	Issue Type +	En	Location *		
Category	Supplemental			GPS Latitude/Longitude		
				Start	End	
Item	DWR UCIP Field Study			39.371934 °	39.371934 °	
				-122.012945 °	-122.012945 °	
DWR ID

Comment Code						
Inspector Comment						
FS_ID:51910 DS_ID:16442 EP_NO: N/A Repair Type: Non-Urgent Crossing Status: Found UCIP Comments: 5/3/2017 Abandoned- needs to be done so properly. (DWR Sutter Yard- A Freitag)10/24/2016 Abandoned.(DWR Sutter Yard- A Freitag)4/25/2016 Abandoned crossing4/21/2015 Slide gate is still buried.6/23/2014 Same as last inspection.12/17/2013 Same as last inspection.7/22/2013 Same as last inspection.10/30/2012 Slide gate is buried-non-fuctional. This crossing was listed in the USACE Periodic Inspections as ID# USACE_CESPK_MA1C_2010_p_0457 for buried slide gate. FIELD_STRUCT_DESC: *ABANDONED* 36-inch corrugated metal drainage pipe through the levee at approximately 15-18 feet below the crown. Slide gate on the waterside (WS) end. (Davis Ranches) [Additional Reference(s): DWR Levee Log, 1992]. FS Date: 5/23/2017 12:02:52 PM

Overview of levee crown looking downstream at crossing.

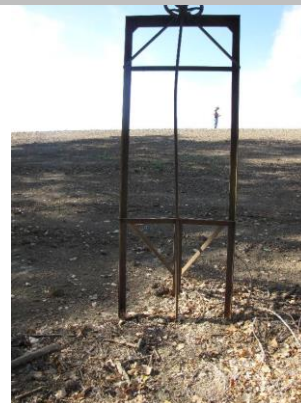
Photo 2 of 2 : UCIP_SP_2018_51910_70380.jpg

Item	DWR UCIP Field Study			39.371934 °	39.371934 °	
				-122.012945 °	-122.012945 °	
DWR ID						
Comment Code						
Inspector Comment						
FS_ID:51910 DS_ID:16442 EP_NO: N/A Repair Type: Non-Urgent Crossing Status: Found UCIP Comments: 5/3/2017 Abandoned- needs to be done so properly. (DWR Sutter Yard- A Freitag)10/24/2016 Abandoned.(DWR Sutter Yard- A Freitag)4/25/2016 Abandoned crossing4/21/2015 Slide gate is still buried.6/23/2014 Same as last inspection.12/17/2013 Same as last inspection.7/22/2013 Same as last inspection.10/30/2012 Slide gate is buried-non-fuctional. This crossing was listed in the USACE Periodic Inspections as ID# USACE_CESPK_MA1C_2010_p_0457 for buried slide gate. FIELD_STRUCT_DESC: *ABANDONED* 36-inch corrugated metal drainage pipe through the levee at approximately 15-18 feet below the crown. Slide gate on the waterside (WS) end. (Davis Ranches) [Additional Reference(s): DWR Levee Log, 1992]. FS Date: 5/23/2017 12:02:52 PM

WS-Slide gate buried-non-functional.

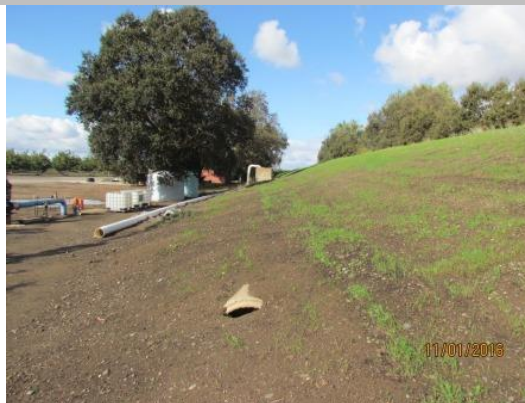
Photo 1 of 1 : SP_2018_MA0001_297_128_20180305_00037.jpg

LM Start	14.25	Rating **	U	Issue No.	128
LM End	14.30	Issue Type +	En	Location *	LS
Category	Earthen Levee			GPS Latitude/Longitude	
				Start	End
Item	Encroachments			39.378129 °	39.378800 °
				-122.013040 °	-122.013360 °
DWR ID	DWR_MA0001_01_f_2016_128				
Comment Code					
PI : Pipe					
Inspector Comment					
Concrete pipe runs along the landside toe and concrete box at the end.

View of a concrete pipe that runs along the levee toe.

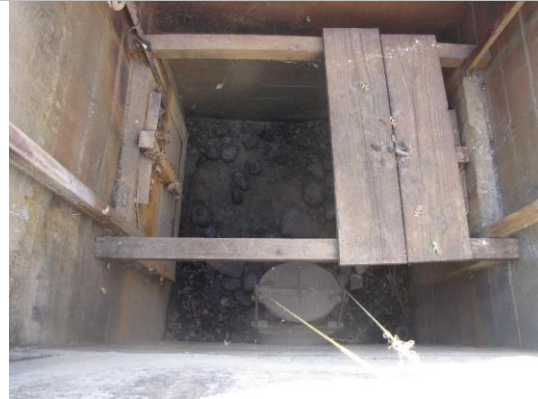
Photo 3 of 3 : UCIP_SP_2018_51912_70381.jpg

FS_ID:51912
DS_ID:16441
EP_NO: 9460
Repair Type: Urgent
Crossing Status: Found
UCIP Comments: 5/3/2017 Water leaked through this crossing during the Jan/Feb 2017 high water event. A concrete pipe of unknown diameter exits the LS distribution box and follows the levee alignment downstream about 120ft and uncontrolled water flowed from that pipe end. If crossing is abandoned then it needs to be done so properly. (DWR Sutter Yard- A Freitag)10/24/2016 This entire crossing now appears to be abandoned. The pvc pipe that was previously connected to the LS well pump is no longer connected and used to fill the box. (DWR Sutter Yard- A Freitag)4/25/2016 WS concrete box appears to be abandoned. LS box appears to get filled by a well pump on LS.4/21/2015 Same as last inspection.6/23/2014 Same as last inspection.12/17/2013 Same as last inspection.7/22/2013 Same as last inspection.10/30/2012 Need to determine if crossing is still being used there are some abandoned features that remain at this crossing-- crossing has been modified. This crossing was listed in the USACE Periodic Inspections as ID# USACE_CESPK_MA1C_2010_p_0464 for abandoned pump station.

Inside view of concrete distribution box located on LS toe.

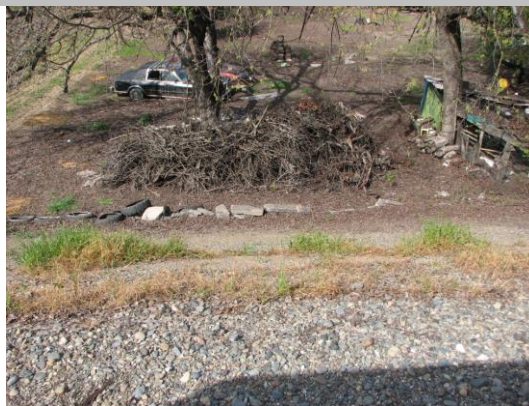
Photo 1 of 1 : SP_2018_MA0001_297_85_20180305_00019.jpg

LM Start	15.79	Rating **	U	Issue No.	85
LM End	15.79	Issue Type +	En	Location *	LS
Category	Earthen Levee			GPS Latitude/Longitude	
				Start	End
Item	Encroachments			39.399929 °	39.399929 °
				-122.010028 °	-122.010028 °
DWR ID	DWR_MA0001_01_s_2016_85				
Comment Code					
DE : Debris					
Inspector Comment					
prunings, concrete and tires.

View of prunings, concrete, and tires along the toe.

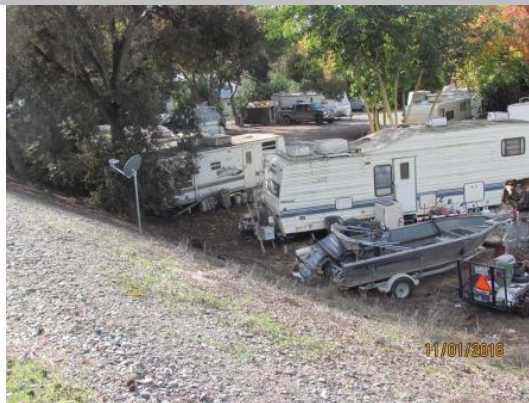
Photo 1 of 1 : SP_2018_MA0001_297_86_20180305_00020.jpg

LM Start	15.84	Rating **	U	Issue No.	86
LM End	15.90	Issue Type +	En	Location *	LS
Category	Earthen Levee			GPS Latitude/Longitude	
				Start	End
Item	Encroachments			39.400601 °	39.401365 °
				-122.009889 °	-122.009374 °
DWR ID	DWR_MA0001_01_s_2016_86				
Comment Code					
BU : Building					
Inspector Comment					
Mobile homes and trailers.

View of the mobile homes and trailers along the landside toe.

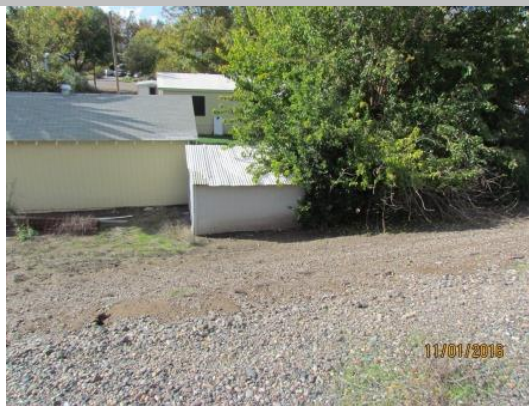
Photo 1 of 1 : SP_2018_MA0001_297_87_20180305_00021.jpg

LM Start	15.95	Rating **	U	Issue No.	87
LM End	15.95	Issue Type +	En	Location *	LS
Category	Earthen Levee			GPS Latitude/Longitude	
				Start	End
Item	Encroachments			39.401994 °	39.401994 °
				-122.009352 °	-122.009352 °
DWR ID	DWR_MA0001_01_s_2016_87				
Comment Code					
BU : Building					
Inspector Comment

View of a shed along the landside toe.

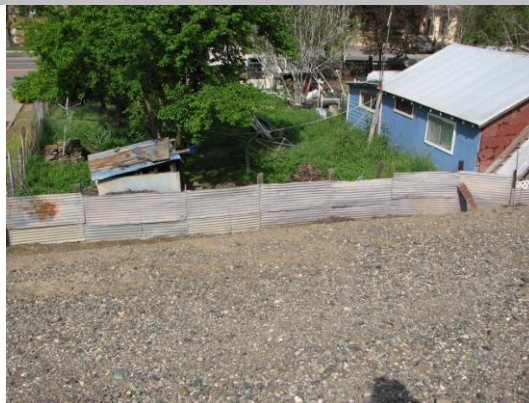
Photo 1 of 1 : SP_2018_MA0001_297_89_20180305_00022.jpg

LM Start	16.00	Rating **	U	Issue No.	89
LM End	16.02	Issue Type +	En	Location *	LS
Category	Earthen Levee			GPS Latitude/Longitude	
				Start	End
Item	Encroachments			39.402756 °	39.403040 °
				-122.009261 °	-122.009186 °
DWR ID	DWR_MA0001_01_s_2016_89				
Comment Code					
BU : Building					
Inspector Comment					
Red house and metal fence.

Corrugated metal fence obstructing visibility and access

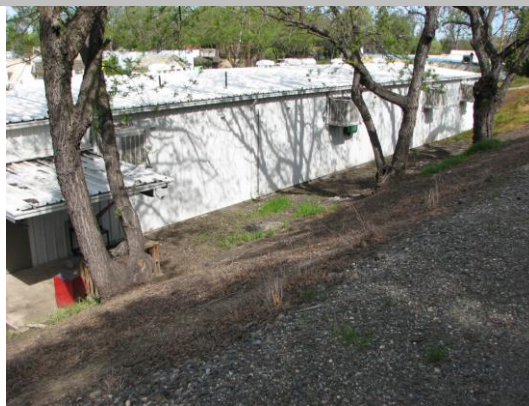
Photo 1 of 1 : SP_2018_MA0001_297_91_20180305_00024.jpg

LM Start	16.06	Rating **	U	Issue No.	91
LM End	16.06	Issue Type +	En	Location *	LS
Category	Earthen Levee			GPS Latitude/Longitude	
				Start	End
Item	Encroachments			39.403565 °	39.403565 °
				-122.009039 °	-122.009039 °
DWR ID	DWR_MA0001_01_s_2016_91				
Comment Code					
BU : Building					
Inspector Comment					
long, white metal building with several AC units

View of a building obstructing access.

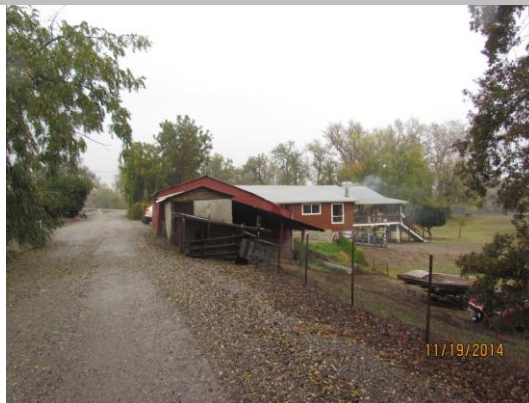
Photo 1 of 1 : SP_2018_MA0001_297_14_20180305_00008.jpg

LM Start	16.08	Rating **	U	Issue No.	14
LM End	16.08	Issue Type +	En	Location *	WS
Category	Earthen Levee			GPS Latitude/Longitude	
				Start	End
Item	Encroachments			39.403930 °	39.403930 °
				-122.008925 °	-122.008925 °
DWR ID	DWR_MA0001_01_s_2012_14				
Comment Code					
BU : Building					
Inspector Comment

View of the building on the waterside slope.

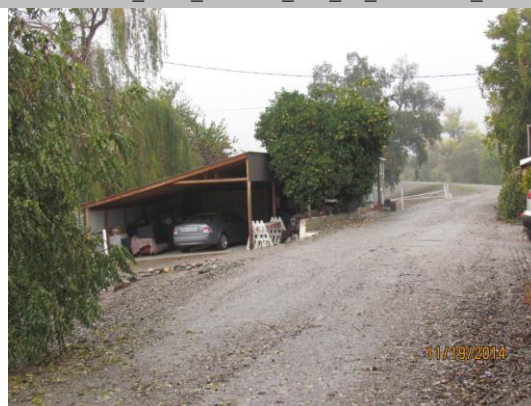
Photo 1 of 1 : SP_2018_MA0001_297_26_20180305_00012.jpg

LM Start	16.10	Rating **	U	Issue No.	26
LM End	16.10	Issue Type +	En	Location *	LS
Category	Earthen Levee			GPS Latitude/Longitude	
				Start	End
Item	Encroachments			39.404135 °	39.404135 °
				-122.008797 °	-122.008797 °
DWR ID	DWR_MA0001_01_s_2012_26				
Comment Code					
BU : Building					
Inspector Comment

View of the building on the landside slope.

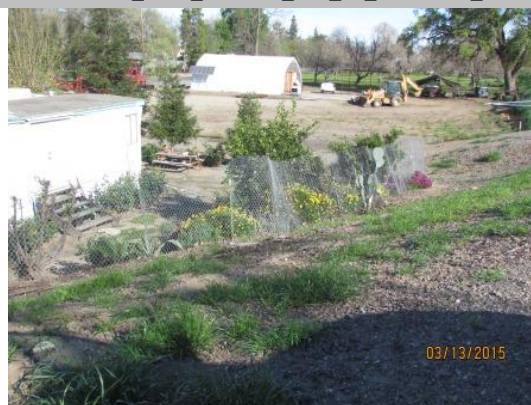
Photo 1 of 1 : SP_2018_MA0001_297_74_20180305_00016.jpg

LM Start	16.10	Rating **	M	Issue No.	74
LM End	16.10	Issue Type +	En	Location *	LS
Category	Earthen Levee			GPS Latitude/Longitude	
				Start	End
Item	Vegetation			39.404255 °	39.404255 °
				-122.008842 °	-122.008842 °
DWR ID	DWR_MA0001_01_s_2015_74				
Comment Code					
V6 : Landscaping					
Inspector Comment					
Remove the landscape from the landside slope and toe.

View of the landscape along the landside slope and toe.

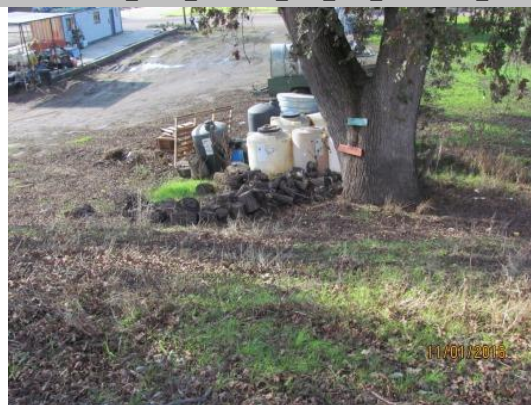
Photo 1 of 1 : SP_2018_MA0001_297_133_20180305_00039.jpg

LM Start	16.17	Rating **	M	Issue No.	133
LM End	16.17	Issue Type +	En	Location *	LS
Category	Earthen Levee			GPS Latitude/Longitude	
				Start	End
Item	Encroachments			39.405147 °	39.405147 °
				-122.008630 °	-122.008630 °
DWR ID	DWR_MA0001_01_f_2016_133				
Comment Code					
FW : Firewood					
Inspector Comment

View of firewood and containers along the landside toe.

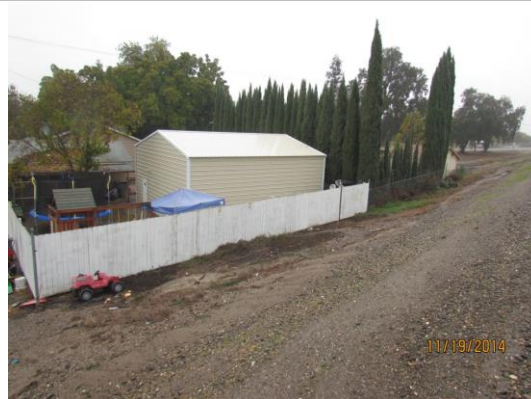
Photo 1 of 1 : SP_2018_MA0001_297_47_20180305_00015.jpg

LM Start	16.34	Rating **	U	Issue No.	47
LM End	16.35	Issue Type +	En	Location *	LS
Category	Earthen Levee			GPS Latitude/Longitude	
				Start	End
Item	Encroachments			39.407670 °	39.407823 °
				-122.008685 °	-122.008740 °
DWR ID	DWR_MA0001_01_s_2012_47				
Comment Code					
FE : Fence					
Inspector Comment

View of the fence along the landside toe.

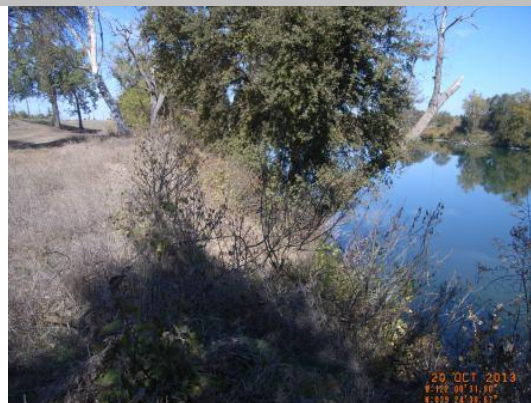
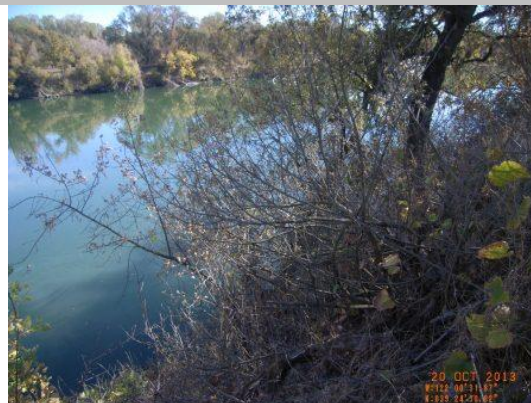
Photo 1 of 2 : SP_2018_MA0001_297_9_20180305_00006.jpg

LM Start	16.35	Rating **	A/W	Issue No.	9
LM End	16.58	Issue Type +	Ma	Location *	WS
Category	Supplemental			GPS Latitude/Longitude	
				Start	End
Item	2015 USACE Erosion Survey, DRAFT			39.407837 °	39.411111 °
				-122.008763 °	-122.009238 °
DWR ID	DWR_MA0001_01_s_2016_9				
Comment Code					
Inspector Comment					
Erosion site added in 1997 and removed in 2005. 2009 - Site added back in, hard toe with slow moving erosion. Potential geotechnical failure. 2011 - Site extended downstream. 2015: Last observed in 2013. [2015 Site ID: SAC_164-3_R]

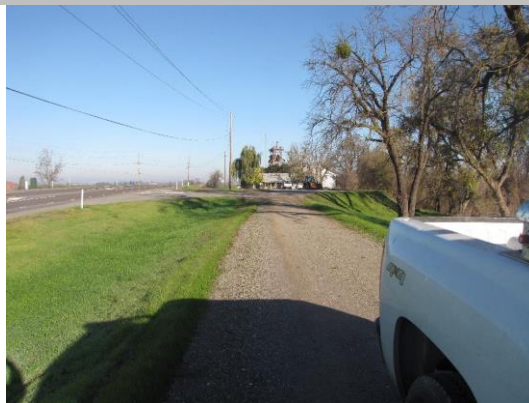
Photo 1 of 3 : UCIP_SP_2018_51916_70391.jpg

FS_ID:51916
DS_ID:16448
EP_NO: 14424
Repair Type: Non-Urgent
Crossing Status: Found
UCIP Comments: 5/3/2017 WS sign still knocked over- needs to be replaced. (DWR Sutter Yard- A Freitag)10/24/2016 WS marker sign still knocked over.(DWR Sutter Yard- A Freitag)4/25/2016 WS marker sign is still knocked over.4/21/2015 Same as last inspection.11/3/2014 (DWR-Olivia) Need to contact owner to determine when markers will be placed. 6/23/2014 Same as last inspection.12/17/2013 Same as last inspection7/22/2013 Same as last inspection.12/2012 Waiting for information regarding crossing from PG&E. Regarding damage warning sign--PG&E has initiated a project to replace pipeline crossing sign and utility markers, as required by DOT codes/regulations.11/2012 Utility warning sign damaged. Olivia (UCIP team) is coordinating with PG&E to determine more info on crossing.
FIELD_STRUCT_DESC: 12-inch gas pipe through the levee, 30-inches below the crown. This 12-inch replacement pipe was installed by horizontally directionally drilling under the State HWY. Crossing is cathodically protected against external corrosion. Line was bored with a minimum cover of 48 feet under the right bank levee, 60 feet under the right bank, 25 feet under the channel and 52 feet under the left bank. Emergency contact: Monte Penland, Gas Maintenance Supervisor, 15871 Central Street, Meridian, CA 95957; Office No. 530-634-6520 or Mobile No. 530-356-7396. Utility crossing coordinates are approximate. This pipe is under pressure and cathodic protection (CP) readings are taken on a regular schedule. (Permit No. 14424, 1988 - Pacific Gas & Electric [PG&E]) [Additional Reference(s): DWR Levee Log, 1992].

View just upstream of utility crossing.
